MI HOME BUYER SURVEY

HOME BUYER SURVEY REPORT

PROPERTY 12 Anyroad Close
Sometown
AB12 3CD

SURVEY DATE 16 Jul 2022

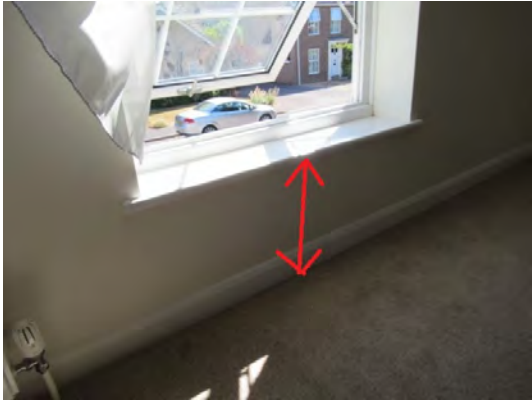
3.2 - Health & Safety related matters	
Fire Risk	Although fire alarms are fitted at the property they have not been tested. You should ensure that there are sufficient devices fitted at the property and that they are all in good working order.
Safety Glass	No issues were noted by the Surveyor.
Lead Pipes	No issues were noted by the Surveyor.
Risk of Falls	<p>Window sills on the first floor are low to the floor for example in bedroom 1, increasing the risk of falls, especially for the very young. You should consider fitting window opening restrictors.</p>

<p>Low sill in bedroom 1</p>
Unsafe Fittings	No issues were noted by the Surveyor. Fittings within the property, where possible, were checked for normal everyday use, but have not been inspected or tested for safety purposes.
Insect and Rodent Infestations	No issues were noted by the Surveyor.
Recent testing of services	No verifiable documentary evidence of recent inspection of the electrical or gas/heating installations was seen at the time of the survey.

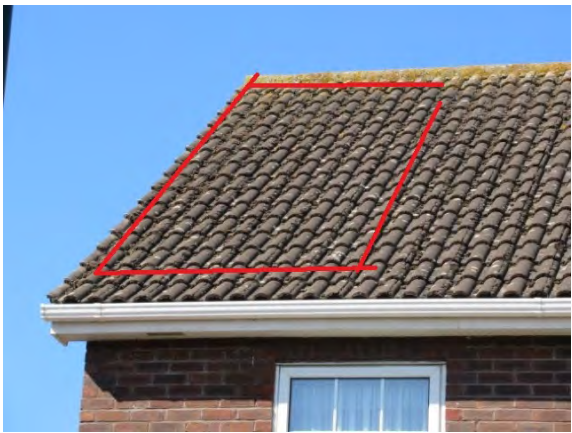
Condition	<p>No significant defects were noted and the roof was found to be structurally stable. No evidence was seen of unusual sagging or other movement which might indicate that the structure is failing.</p> <p>No significant numbers of slipped, chipped, cracked or missing tiles were noted. Some moss growth was evident, for example at the front, and this should be cleared as a matter of routine maintenance to prevent over-weighting the roof structure.</p> <p>Carry out normal maintenance including removal of moss build-up. Any slipped, missing or broken tiles on the roof pitches should be repaired and replaced. You should carry out a thorough visual inspection at least once a year, ideally in the Spring to identify and repair any damage that could have been caused by winter weather.</p>

<p>Moss growth on the front roof pitch</p>

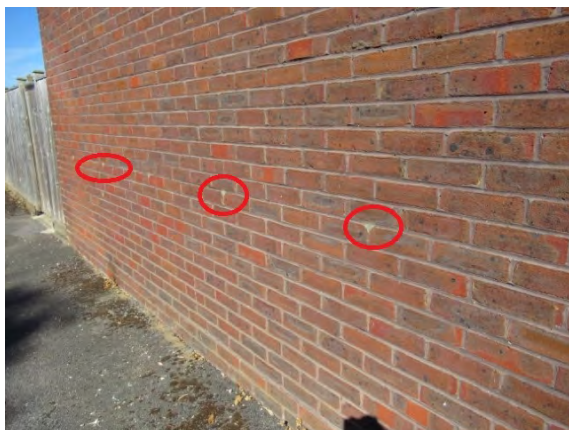
Cavity Wall Insulation drill marks

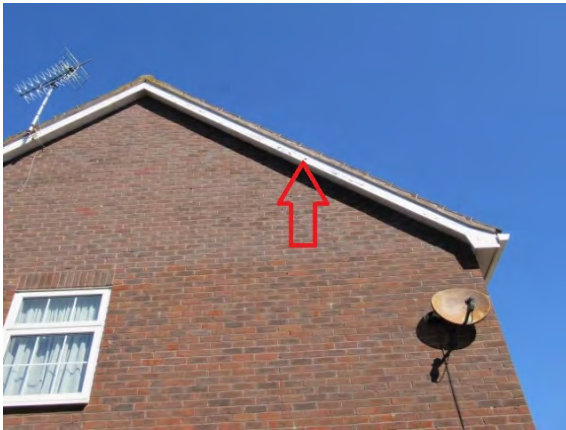
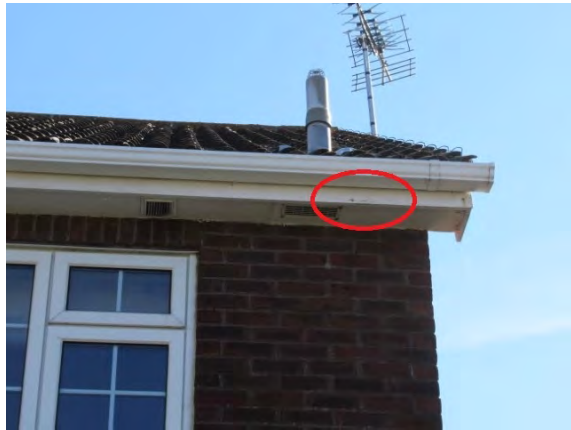
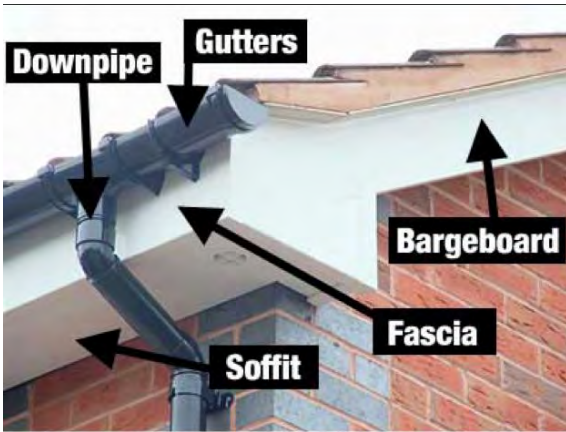
4.6 External Joinery and Finishes	Condition rating	2
Construction & Type and Limitations	<p>This includes such items as woodwork at the roof edges, trim panels and any timber porch/canopy. Soffits are the horizontal timbers joining the fascia boards to the house walls. Fascia boards are the vertical timbers to which the gutters are normally fixed. Barge boards are the diagonal boards at the roof edge on the gable end of the house.</p> <p>All such materials were examined from ground level and with the aid of binoculars from vantage points within the grounds of the property and suitable public areas around. Decorations were examined for indications of poor maintenance, rot and other defects.</p>		
Condition	<p>No significant defects were noted. However, the joinery is in a poorly maintained condition requiring stripping and redecorating to all sides of the property. In such circumstances, many new owners would consider replacing the existing fascias, soffits and bargeboards with low maintenance PVC.</p>

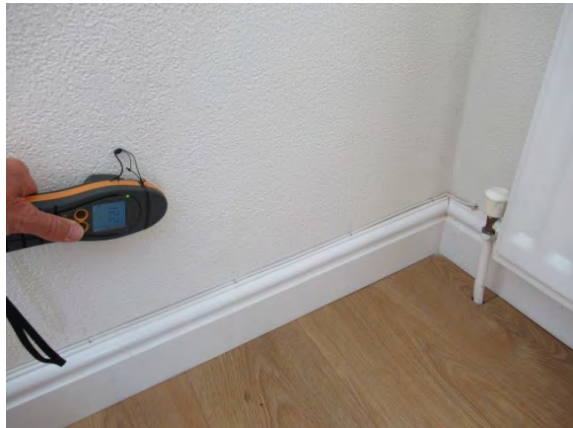
<p>Normal moisture reading on the front wall of the living room</p>

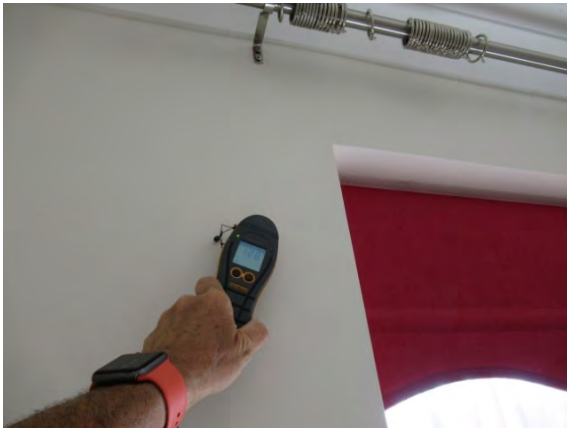
<p>Normal moisture reading on the wall of bedroom 1</p>

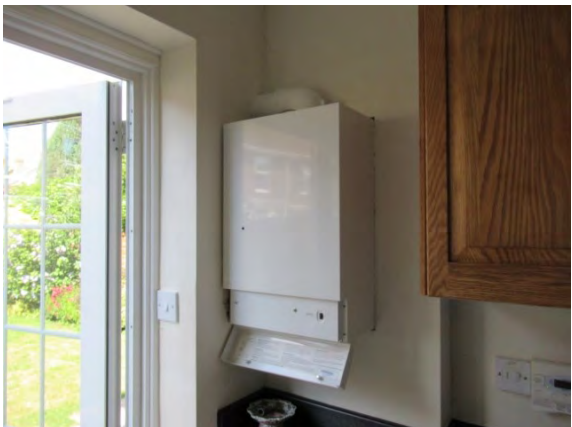
<p>Boiler</p>

<h2>6.4 Heating and Cooling</h2>	Condition rating	3
Construction & Type and Limitations	<p>The heating and hot water is provided by a gas-fired condensing boiler which is located in the kitchen.</p> <p>The boiler is a Main 15 HE A. On the SEDBUK seasonal efficiency database this boiler is shown as having a SAP 2009 annual efficiency rating of 89%. It is believed that this model was manufactured between 2010 and 2015.</p> <p>As a guide, most modern condensing boilers have an efficiency of around 85-90%.</p> <p>It is understood that the boiler was fitted by the current owners in around 2013.</p> <p>Heating is distributed by radiators in most rooms.</p> <p>The heating is controlled by a programmer located beside the boiler, a wall thermostat in the ground floor hall and thermostatic valves on some radiators.</p> <p>Repeated attempts by the owner to ignite the boiler were unsuccessful, preventing any checks of the installation or controls being conducted.</p> <p>It is not possible to fully assess the condition and safety of a gas installation on the basis of a visual inspection only. A visual inspection was carried out of the radiators, pipework and boiler to detect leaks, corrosion and other common defects.</p>

Condition	<p>The boiler is believed to be approximately 5 years old and, therefore, around one third of the way through its normal expected service life. Under normal circumstances a modern boiler will last for 15-20 years before requiring replacement.</p> <p>No evidence was seen to suggest that an inhibitor has been added to the heating system recently to prevent a build-up of sludge in the pipework and radiators, and it is therefore recommended that the system be flushed through and an inhibitor added.</p> <p>Gas Safe recommends that all gas appliances and boilers are inspected and serviced according to manufacturer's guidance, but at least once a year. A gas installation can look to be in a safe condition, but serious defects may be hidden, some of which can kill. It is therefore considered to be essential that you commission an inspection of the gas/heating installation prior to purchase of the property, unless you are provided with verifiable evidence that such an inspection has recently been carried out by a competent person. You can get more information, or find a Gas Safe registered engineer https://www.gassaferegister.co.uk/find-an-engineer/</p>

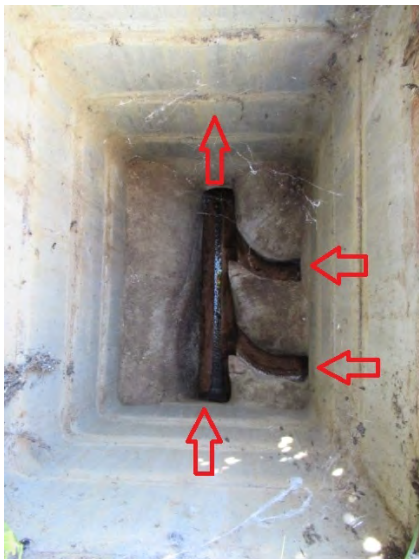
Condition	<p>Water was seen to run through the chamber with no blockages or undue levels of silt being apparent. The flow is from the house and forwards to the chamber at the front, whereupon it is directed to the left within a shared drain, presumably to a main sewer.</p> <p>Drains should be regularly inspected to ensure they remain free from blockages, tree root damage or other obstructions.</p>

<p>Inspection chamber in the front garden with the house to the right of the picture and the flow direction indicated</p>

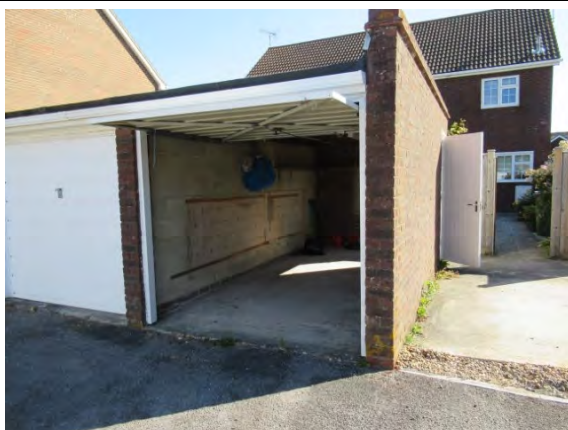
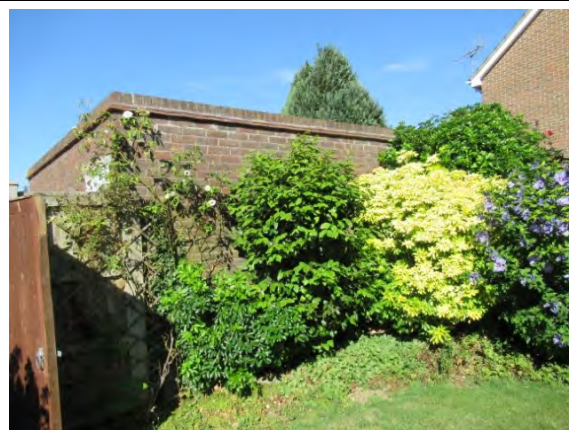
Garage

The garage was found to be in a good condition with no obvious significant defects. Both doors were found to operate normally.

Compared to traditional coverings such as tiles and slates, most felt roofs have a typical life of 10-25 years. They are also prone to sudden failure and leakage. Periodic re-covering will therefore be necessary. When this is undertaken, the supporting structure may also need some attention.

Foliage and debris should be removed from the outside walls.

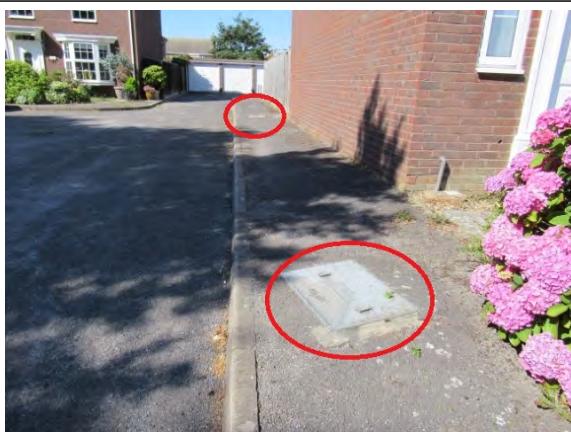
Raised manholes in the footpath to the left side
