MI HOME BUYER SURVEY

HOME BUYER SURVEY REPORT

PROPERTY 12 Anyroad Close
Sometown
AB12 3CD

SURVEY DATE 16 Jul 2022

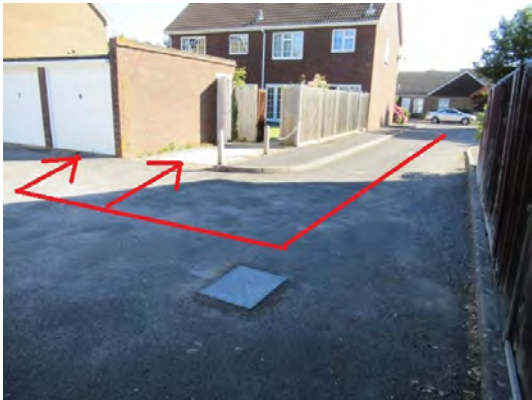
<p>Access to the garage and parking space</p>
Easements & Wayleaves	<p>In simple, but non-legal terms, an easement is the right of one landowner to make use of another nearby piece of land for the benefit of his own land. An example may be that of a right of way across land belonging to someone else to gain access to a garage or gate. A wayleave is a right for someone (usually a utility company) to take pipes, wires or cables across another's land. Nothing was seen at the site which suggested that such rights may exist, but you should check with your legal advisor who will have seen any relevant documentation.</p>

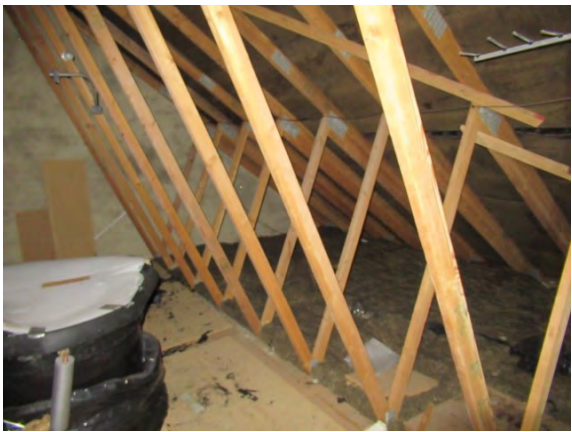
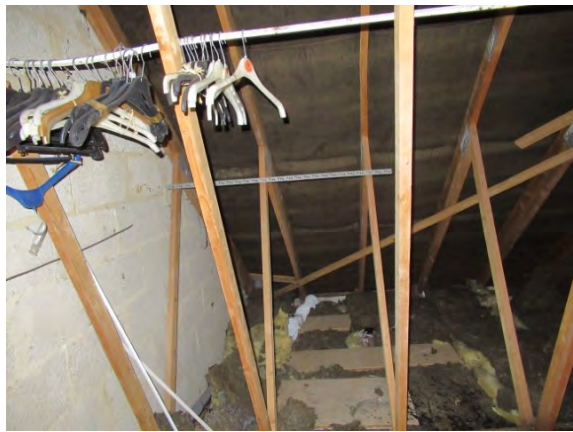
<p>Condition</p>	<p>No significant defects were noted during my inspection and the roof was found to be structurally sound.</p> <p>No evidence was seen of any unusual movement or stress of the supporting timbers within the roof, and there have been no obvious significant alterations to the structure which might have resulted in it becoming substantially weakened.</p> <p>Between the outer tile covering and the inner timbers is an underlining, sometimes called "sarking". It is present to provide an additional weather-proofing layer to moisture, snow and rain etc. that may be blown past the outer covering. In older properties it may not be present at all. Typically, in the 1920's the sarking is of timber planks. Later properties often have a layer of bituminised felt, while in modern properties a breathable membrane, such as Tyvek, is normally used. In this case the sarking is of bitumen felt. It was found to be in a mostly undamaged condition and is considered to be suitable for its purpose.</p> <p>Other than in those areas which have been boarded, the roof space is laid with approximately 200mm of wool type insulation at joist level. This is close to the current recommendation of 270mm for maximum energy efficiency. It does, however, limit movement and storage within the roof space as any supporting joists are concealed.</p> <p>High moisture levels within roof spaces are responsible for the promotion of the development of timber defects such as rot and infestations by wood boring insects (commonly known as woodworm). Wood moisture content readings taken were found to be well within normal limits and below the levels normally required for this type of defect.</p> <p>Care should be taken when moving around, or storing heavy objects, in the roof space. The spaces between the floor joists will not support a person's weight, or that of large boxes etc. Where heavy items are to be stored it is important to distribute the weight evenly using fixed boards. Additional structural support may be required if you plan to store large quantities of heavy items in the roof space.</p>

<p>Looking towards the right</p>
	<p>Looking towards the left rear</p>
